Navajo Abandoned Uranium Mine

Site Screen Report

Mine Name: **June** Mine ID: **534**

August 2011

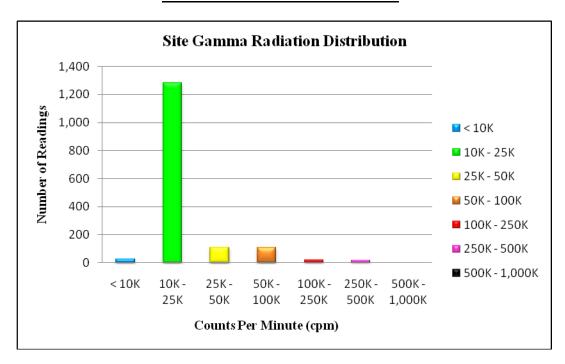
Highest gamma radiation measurement: 330,435 counts per minute (cpm)

Background Average: 8,979 cpm **Two Times Background:** 17,958 cpm

A total of 1,567 gamma radiation measurements were collected from the mine site, ranging from 8,512 cpm to 330,435 cpm. The measurements are represented in Figures 1 and 2.
